# Water Review

## The Minidoka Project

Water Users, USBR Seek Multi-Million Dollar Fix to Aging Spillway

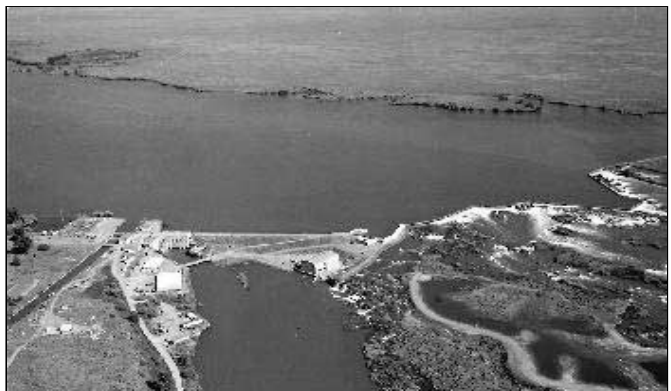
***Minidoka Dam and Reservoir in Idaho***

The Minidoka Dam and Spillway was built between 1905 and 1907, and the spillway pillars were built in the fall of 1909. The integrity of the concrete mix used at that time was inconsistent.

During the winter of 1926-27, the full reservoir behind the dam froze over. The ice pressure on the spillway broke, and the spillway crest actually moved about six inches in three locations. In the late summer of 1927, holes were drilled in the 2,200 foot spillway, and rebar was driven into the concrete to hold the structure in place. Since that time, the reservoir has not been allowed to fill during winter months.

The gated spillway structure has been evaluated by the Bureau of Reclamation, which has recommended that it be replaced, since the entire structure is at risk of failure.
